Contract #: 04-0120F4Cty: SF/ALA Rte: 80 PM: 13.2/13.9File #: 69.28**WELDING INSPECTION REPORT****Resident Engineer:** Pursell, Gary**Address:** 333 Burma Road**City:** Oakland, CA 94607**Report No:** WIR-000053**Date Inspected:** 18-Jan-2007**Project Name:** SAS Superstructure**OSM Arrival Time:** 800**Prime Contractor:** American Bridge/Fluor Enterprises, a JV**OSM Departure Time:** 1530**Contractor:** Zhenhua Port Machinery Company, Ltd (ZPMC), Changxing Island **Location:** Shanghai, China**CWI Name:** Liu Liu**CWI Present:** Yes No**Inspected CWI report:** Yes No N/A**Rod Oven in Use:** Yes No N/A**Electrode to specification:** Yes No N/A**Weld Procedures Followed:** Yes No N/A**Qualified Welders:** Yes No N/A**Verified Joint Fit-up:** Yes No N/A**Approved Drawings:** Yes No N/A**Approved WPS:** Yes No N/A**Delayed / Cancelled:** Yes No N/A**Bridge No:** 34-0006**Component:** PQR Test plates**Summary of Items Observed:**

WELDING INSPECTION REPORT

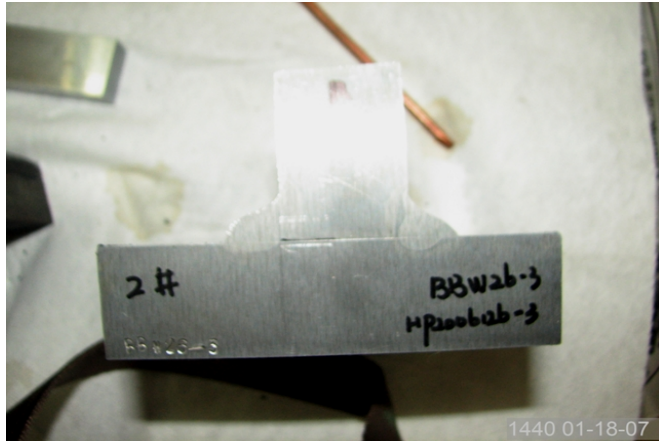
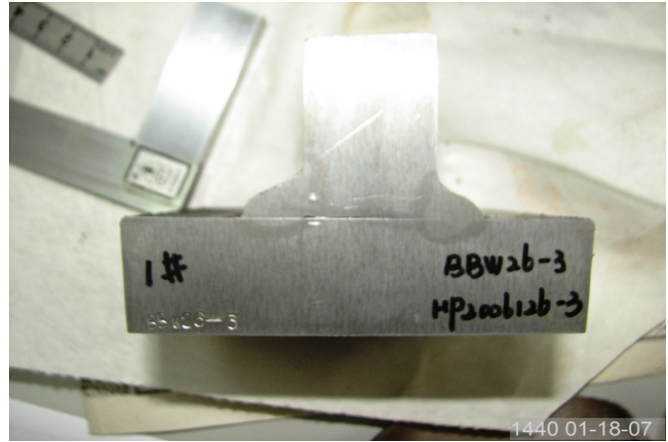
The Caltrans Quality Assurance (QA) Inspector witnessed welding of a Procedure Qualification (PQR) test plate using gas shielded flux cored arc welding (FCAW-G) using Supercored 71H electrode, in the 2F (horizontal) position. The welding was performed per the AWS D1.5, 2002 Section 5.10 requirements. The welding appeared to comply with the contract documents. The PQR fillet weld test plate weld soundness test was performed in accordance with AWS D1.5-2002 paragraph 5.10.3 and the results were evaluated in accordance with AWS D1.5-2002 paragraph 5.19.3. Caltrans lot number B31-016-07 was assigned for tracking purposes.

On this date the QA representative Joe Lanz arrived at a machine shop operated by Mr. Zhang Sheng Qiang of to witness machining of Procedure Qualification test plates for destructive testing. The test plates appeared to be HP2006129 and HP2006131. The QA inspector observed that machining of samples for reduced section tensile tests, side bends and Charpy V-notch were in progress. The QA inspector observed that all samples were stamp marked prior to machining to maintain traceability. The machining appeared to be in accordance with the requirements of AWS D1.5-2006 section 5. Pictures are on file. The machining was not completed on this date.
